Home Purchase Building Survey

Inspected Property Address:
100 College Road HA2 XXX

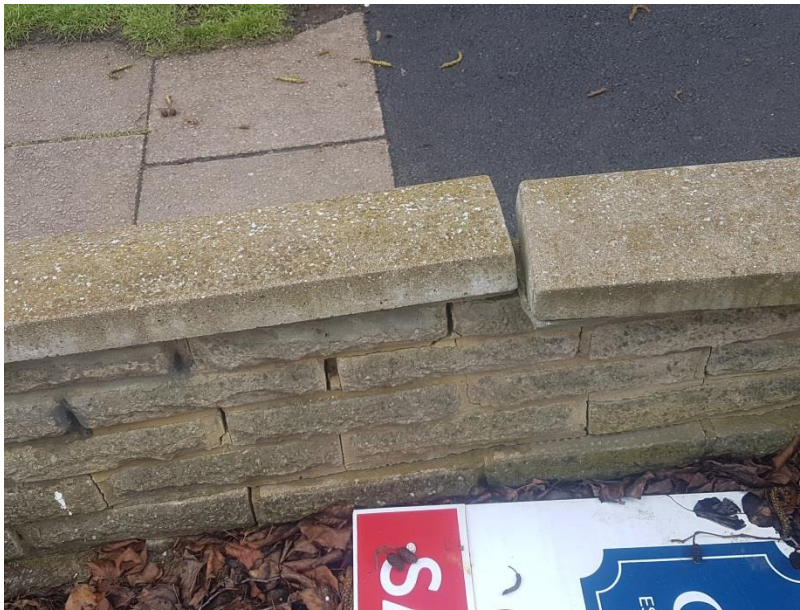
P1. Structural Movement

However the front boundary brick built wall has cracked and requires rebuilding. See photo P1

- Fix/replace front Upvc fascia section that is missing
- Fix front boundary wall that has cracked.
- Re-apply sealant to bathroom fittings around edges to recreate a waterproof seal.

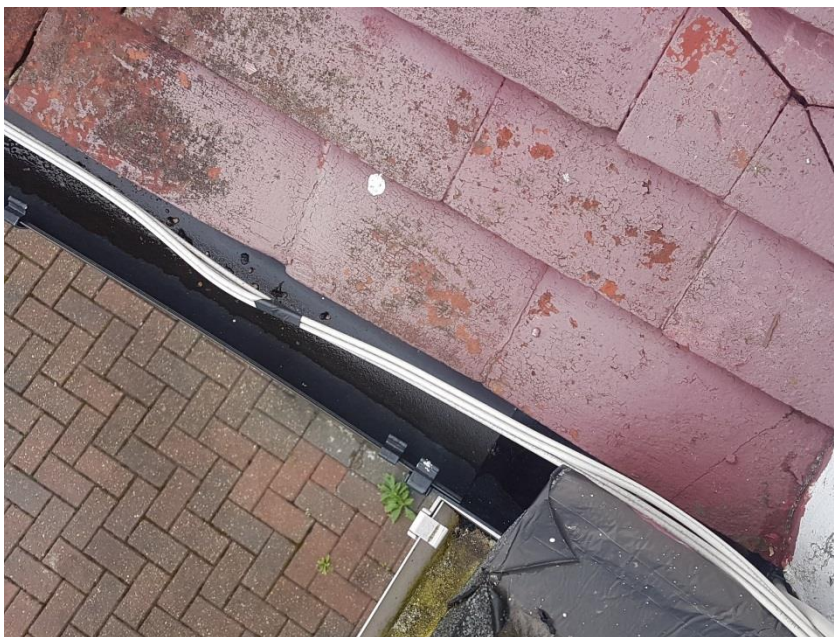
P2. Roofs

The roof surfaces appear in generally acceptable condition. However there are causes for concern with the roof. The coverings are weathered in places and partially slipped or cracked tiles can be seen on the main roof and right side roof above the flat roof extension. See P2/P3

- Fix leak to rear gutter that is leaking onto pitched roof below.
- Re-seal with more permanent sealant the downpipe on the flat roof.
- Re-fix broken/slipped tiles to main front roof.

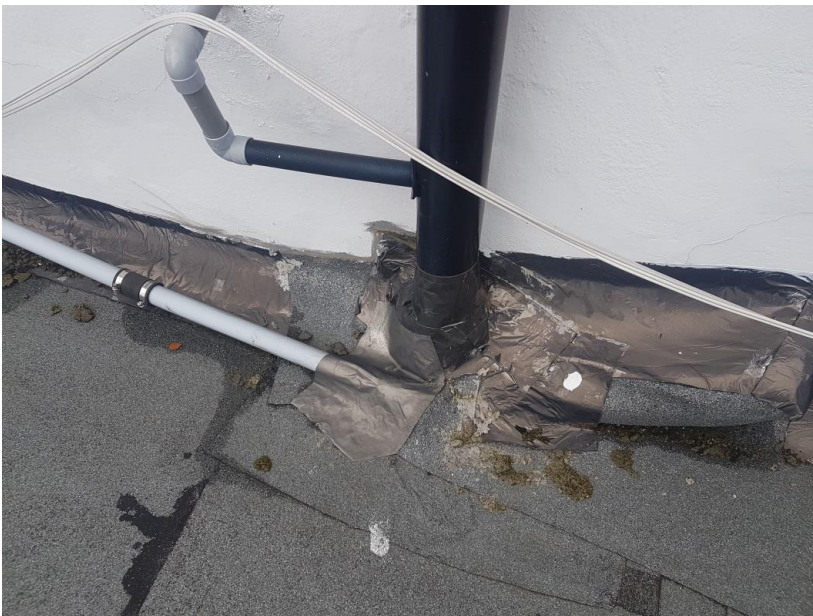
P4

This has been covered in traditional mineral felt. No ponding of water was noted but the junction of main wall and top of roof has been untidily sealed together with the downpipe and may require further investigation. No damp was noted internally. See P4.

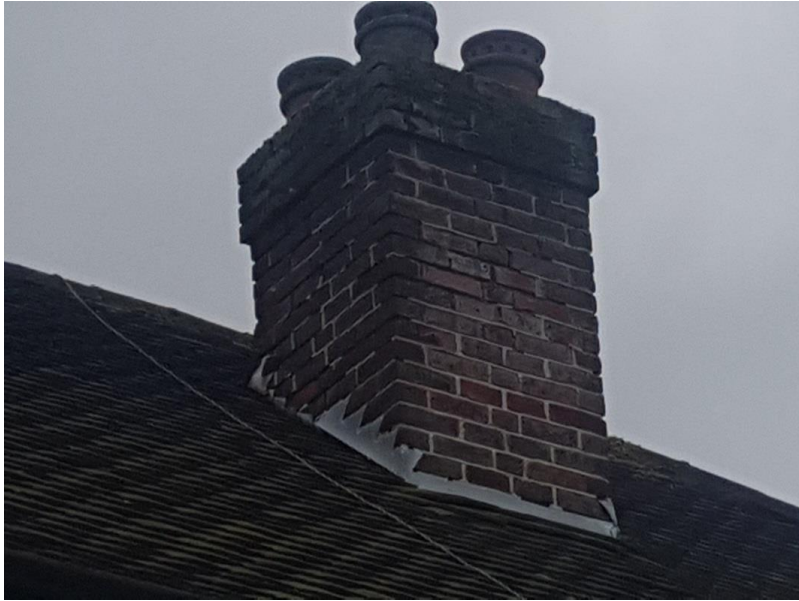
P5. Chimneys

Lead work noted as an apron where the actual chimney stack is in situ. This appears insufficient in the upper part of the stack as the depth is much lower than the rest of the lead apron. This could lead to penetration of damp/water into the roof space. P5

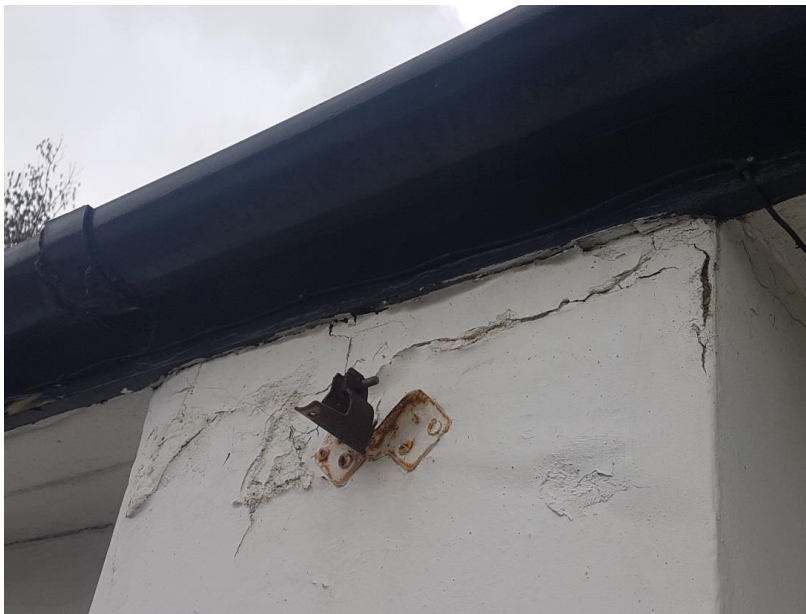
Cracking to the top of the rendered wall can be seen at the rear. This could possibly from an old satellite installation which proved too heavy for the anchor bolts. This should be fixed as part of your planned maintenance program. P8

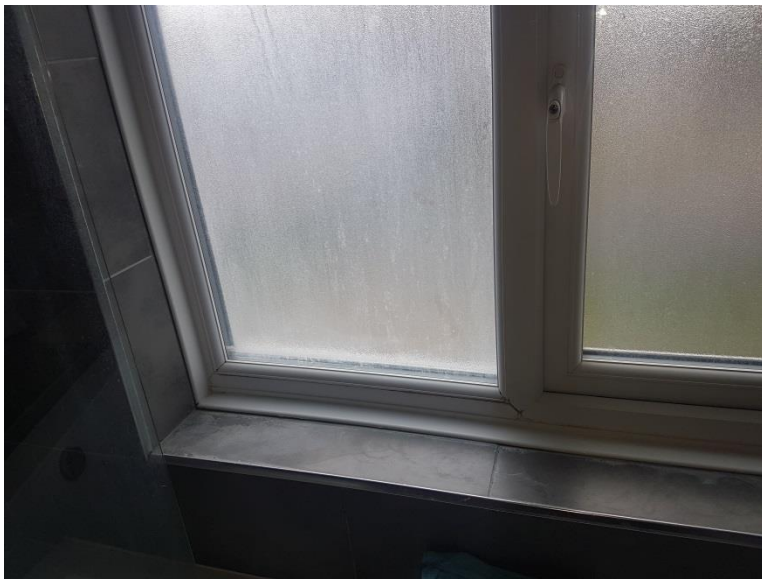
P9. Doors & Windows

Most of the windows are in good repair with no evidence of misting. However the bathroom unit has misted and the seals have perished. Plan for a replacement unit in the future. P9

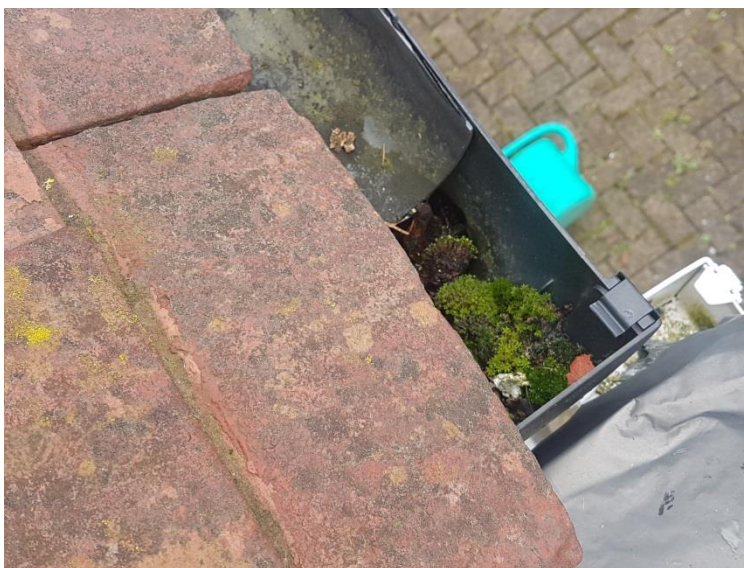
P10. Drainage

It was noted that most gutters appeared blocked with leaves/moss and debris. P10/P11.

- Legal to investigate all relevant documentation regarding side extension in place.
- Clear all gutters from Moss & debris and reattach drain guards that are missing/broken.

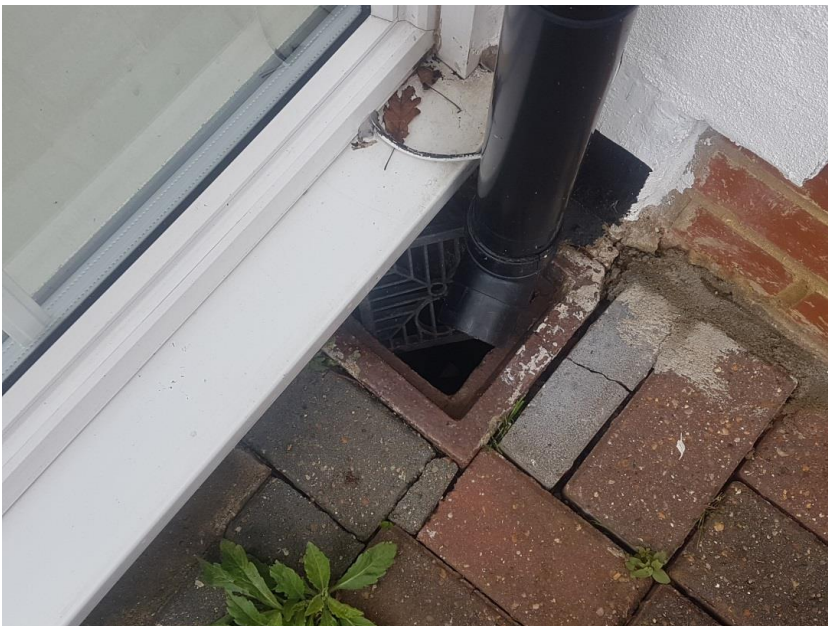
P12

It is essential that these are regularly monitored and swept of any materials that can increase the chance of water build up leading to damp. Several drain guards are missing and need replacement. P12/P13/P14

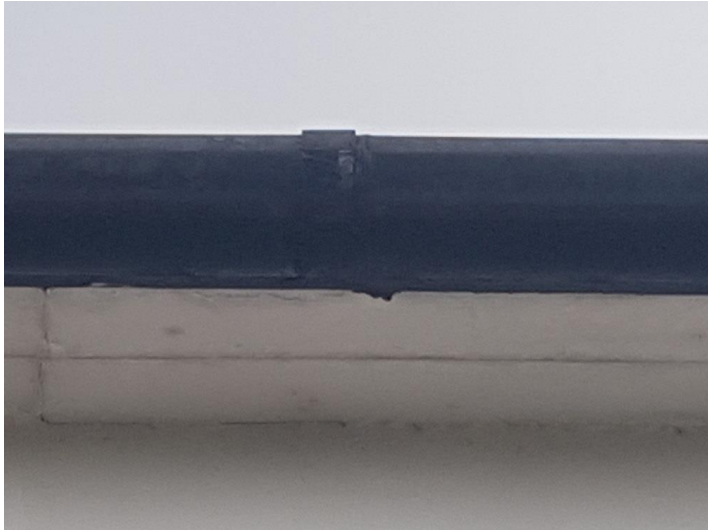
P15.Guttering

We noted a broken gutter to rear which is dripping water onto Kitchen pitched roof below. This is an urgent matter. See P15/P16

This is leaking onto pitched tiled roof below constantly

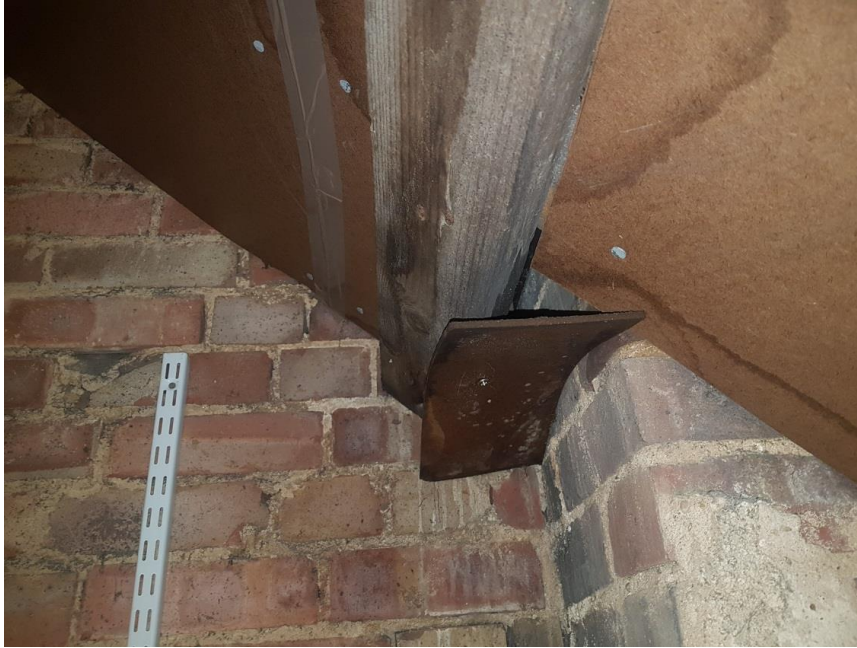
P23

(Staining was noted to the timber boarding beneath the chimney stack in the loft space. P23). This is indicative of water penetration through the roof down the chimney. Cannot confirm this has been fixed !..note timber boarding fixed to rafters preventing inspection and the BLUE bucket under the supported stack in P25/26.

The stack is unlikely to have a DPC. If well maintained no work needed but as masonry is very exposed, budget for improvement. (Staining was noted internally around base of where Chimney goes through roof in loft. (P23))

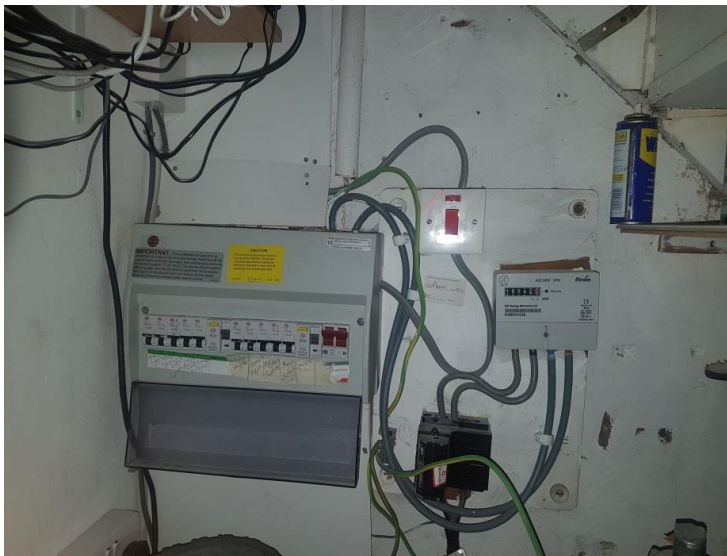
P29. Services

Modern electrics in situ. Modern meter and consumer unit situated in under stairs cupboard with RCD switch in situ. This was tested and found to operate satisfactorily. P29

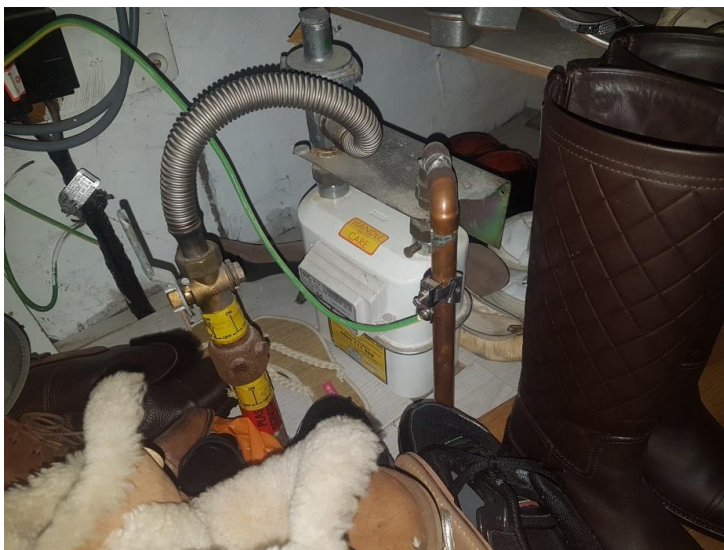
P30. Gas meter

Mains gas noted at the property. The meter and cut off valve is located in the cupboard under the stairs. P30

We recommend that all valves at the property should be tested and have the necessary tools readily available in case of emergency to operate these valves and confirm from the
